Comparative Analysis Executive summary

Saint Paul's Complex
Garden City, NY, 11530

EXECUTIVE SUMMARY

Existing MEP/FP Condition Evaluation & Adaptive Reuse Analysis

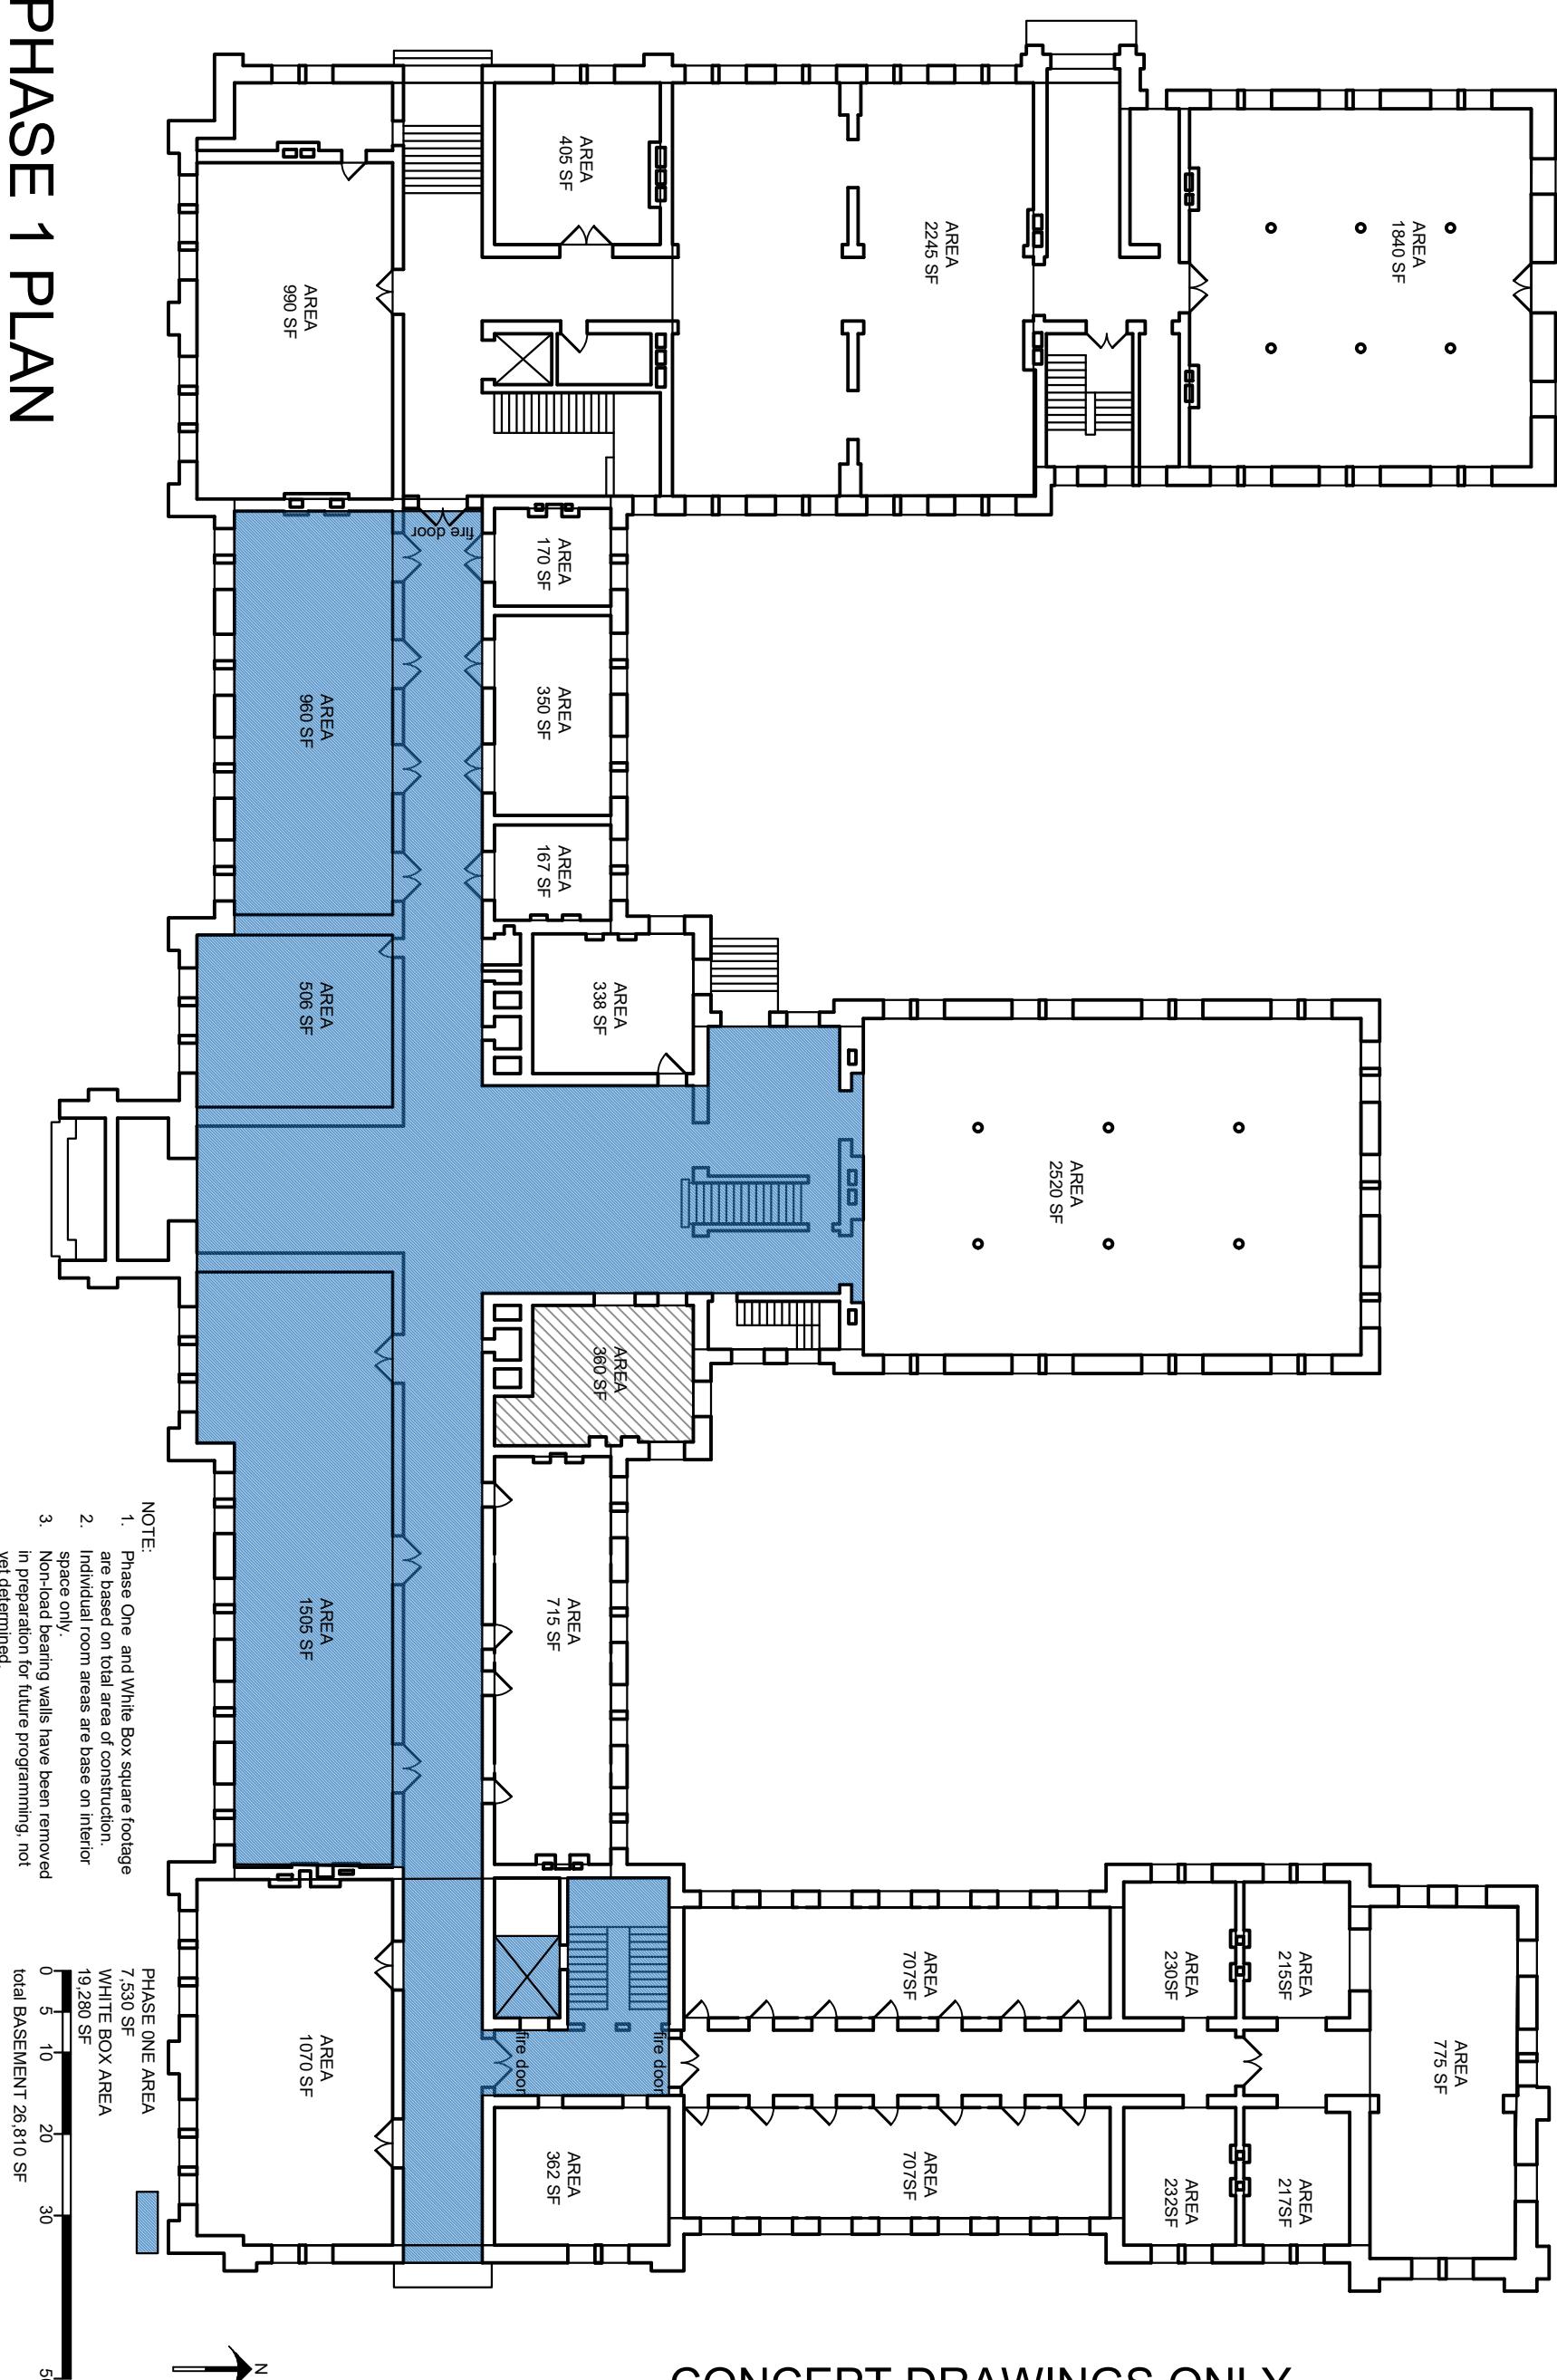
PHASE 1 PLAN

1. BASEMENT SHOULD HAVE ALL MATERIALS AND FURNISHES REMOVED
2. REMOVE ABANDONED PIPING AND DUCTWORK
3. WALLS FLOORS AND CEILINGS SEEM STRUCTURALLY SOUND BUT AFTER DEBRIS REMOVAL A FULL STRUCTURAL EVALUATION SHOULD BE COMPLETED.

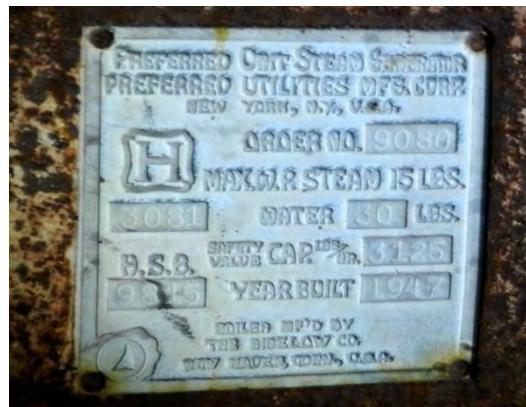
Existing boiler manufacturer by Preferred utilities

The existing heating plant consisted of two (2) steam boilers as per the nameplate above. These were installed in 1947 and are unusable for any purpose in a retro-fit program.

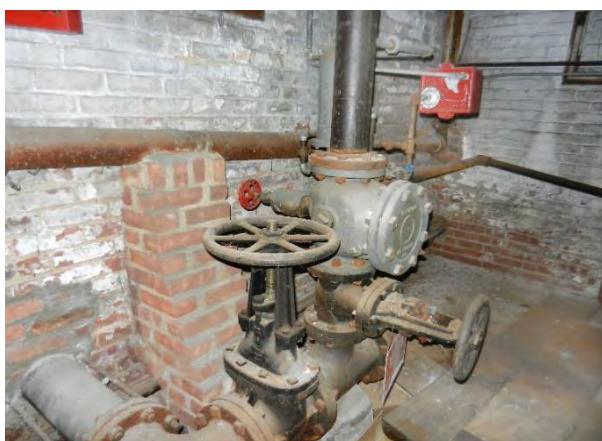
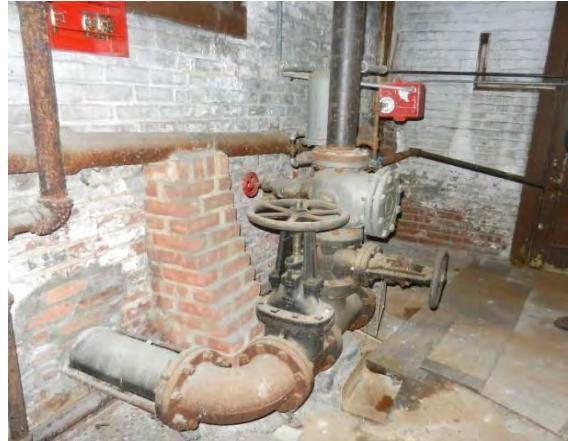
Plumbing/Fire Protection

The current fire protection system supply is fed from the existing water service.

- A. Any Smoke Detectors installed throughout the building are inoperative, do not meet current codes and cannot be reused.
- B. Fire hose reels are installed at locations near fire exits. These do not meet current codes and the piping is not suitable for reuse due to age and corrosion.
- C. The current building is not protected with a comprehensive sprinkler fire system throughout. Sprinklers are only in the basement and hallways.
- D. The current gas service that enters the building is 2" low pressure gas line. That service has been abandoned.

- E. The plumbing piping system including waste, vent, water piping is original to the building. Systems show signs of failure, waste, and vent piping (cast iron) is cracking. There is some evidence of more updated piping in some areas where replacement was done due to failure. These systems cannot be reused.
- F. The plumbing fixtures in the building are original. Existing plumbing fixtures in the bathrooms include floor mounted tank type water closets. Urinals are wall hung type with flush valve. These fixtures do not conform to current water conservation code requirements.

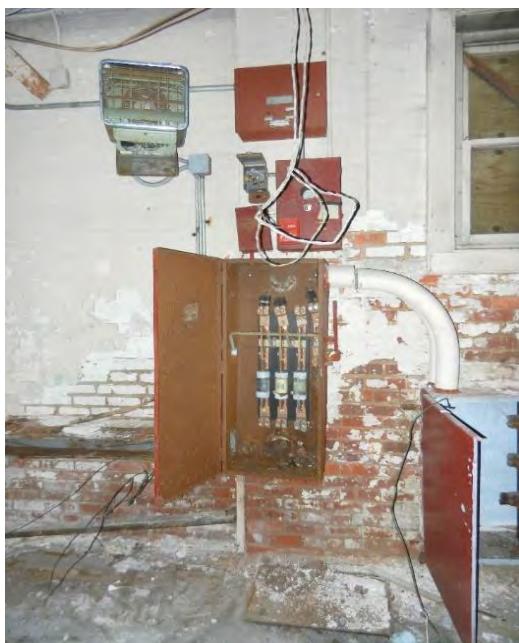
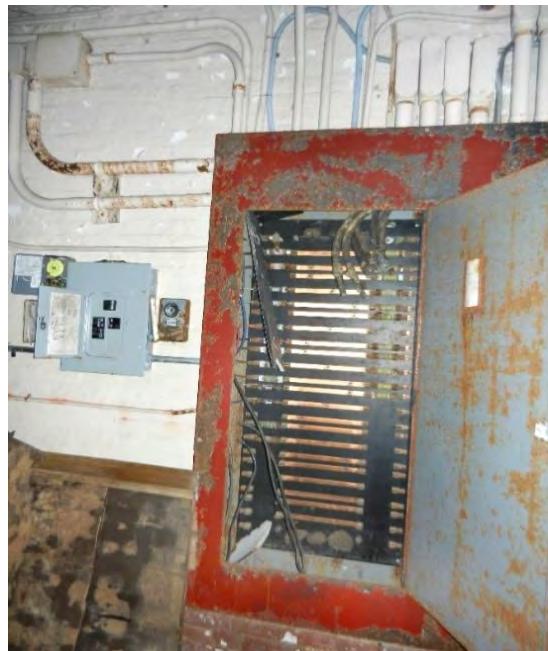
Electrical

- A. The existing electrical service to the building is provided by underground feeders that run to service disconnects the electrical distribution is outdated. Most panel locations are not code compliant with regards to mounting heights.
- B. The entire electrical system is scavenged and needs to be replaced as it is non-compliant with current electrical loads and code. See photos above.

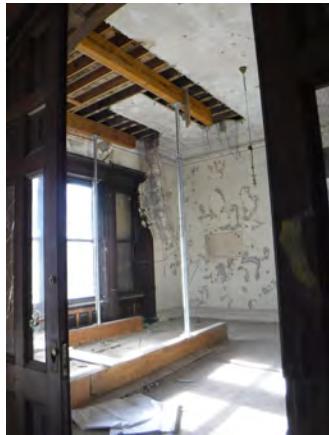
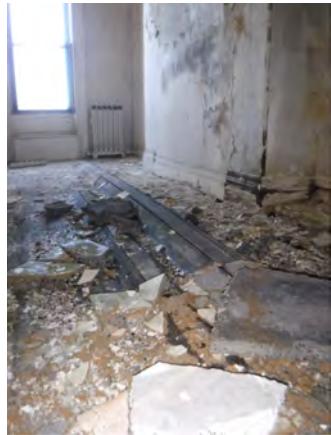
Shoring example on second floor

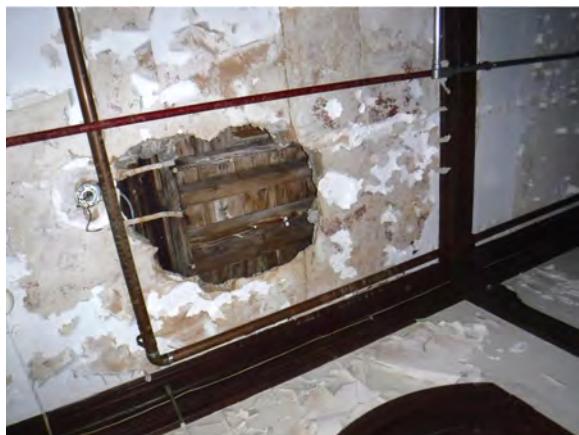
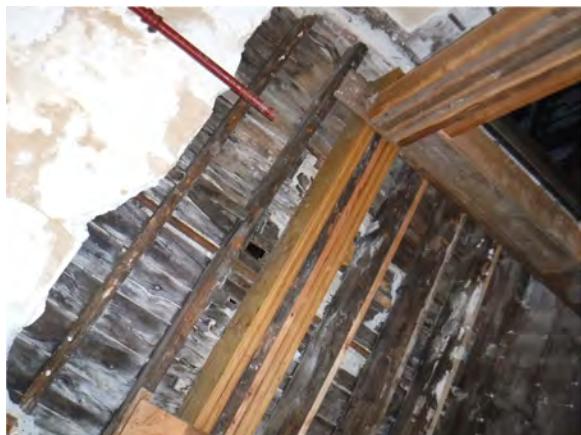
Floor damage

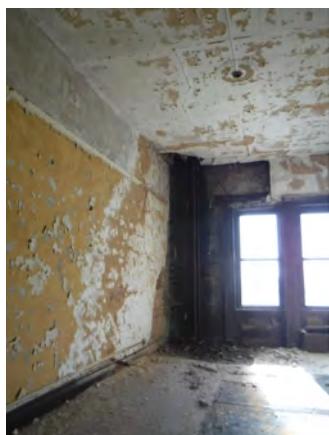
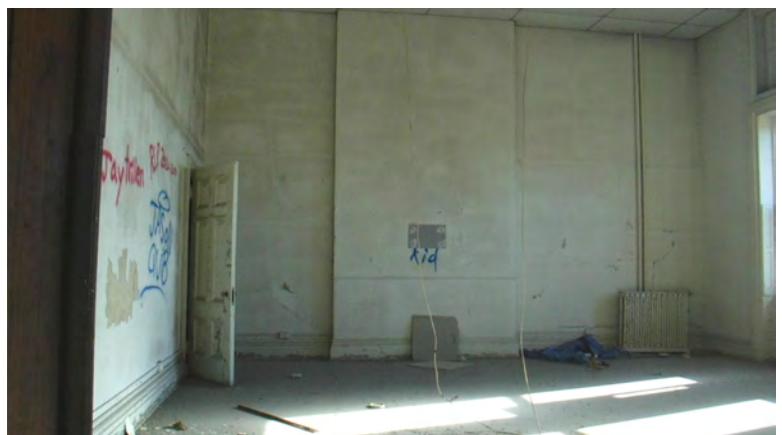
Typical ceiling

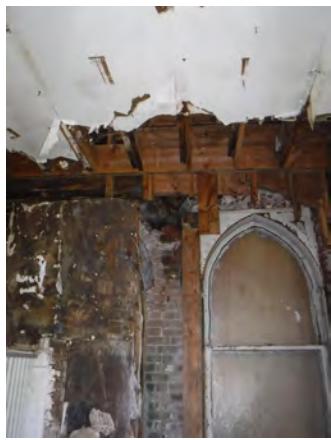
Typical room conditions

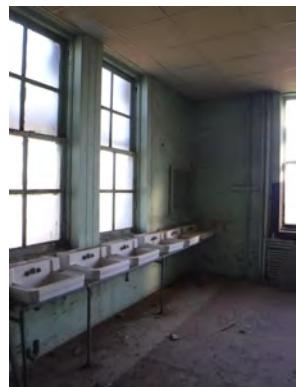
Interior damage towards roofs
