FORENSIC ARCHITECTS AND ENGINEERS

ASSESSMENT OF REPAIRS AND RESTORATION OF ST. PAUL'S SCHOOL, GARDEN CITY, NEW YORK

Re: St. Paul's School
Date: January 21, 2011
Page: 2 of 29

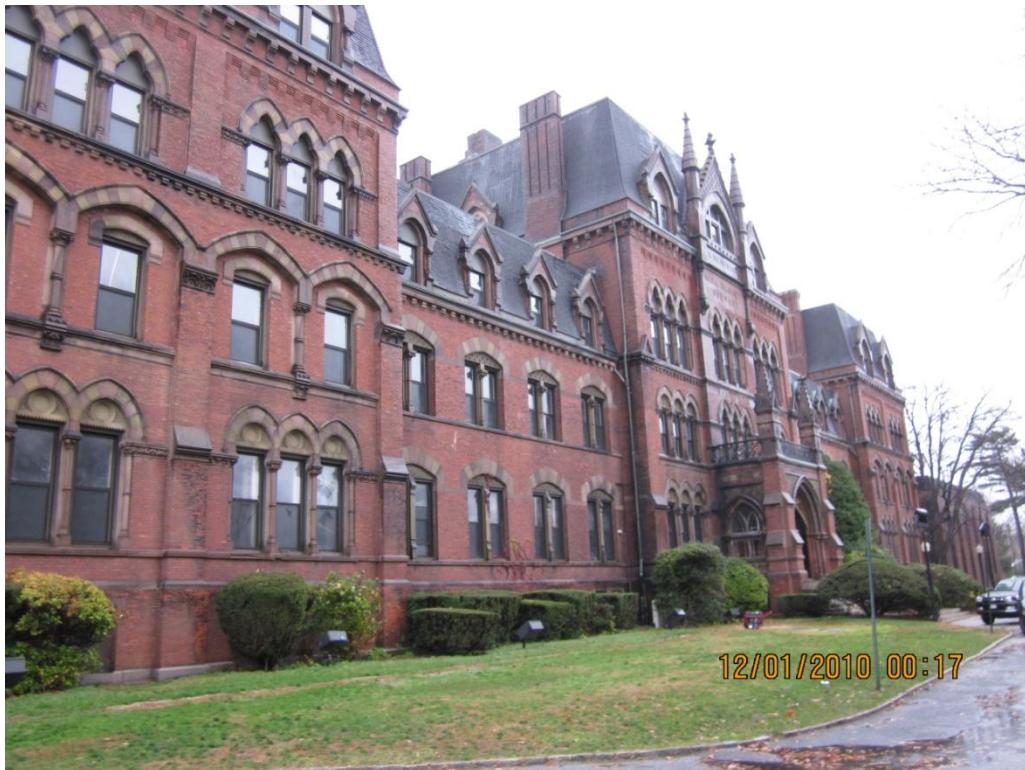
General view of front facade

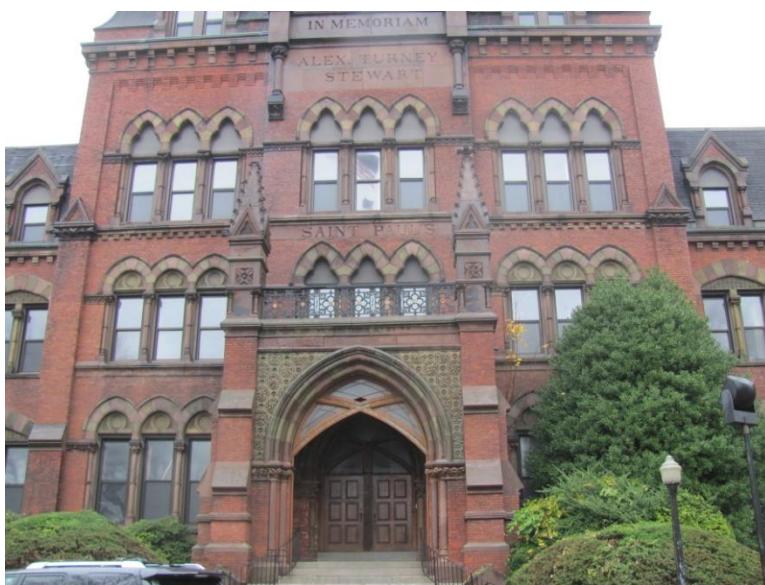
Detail of front entry

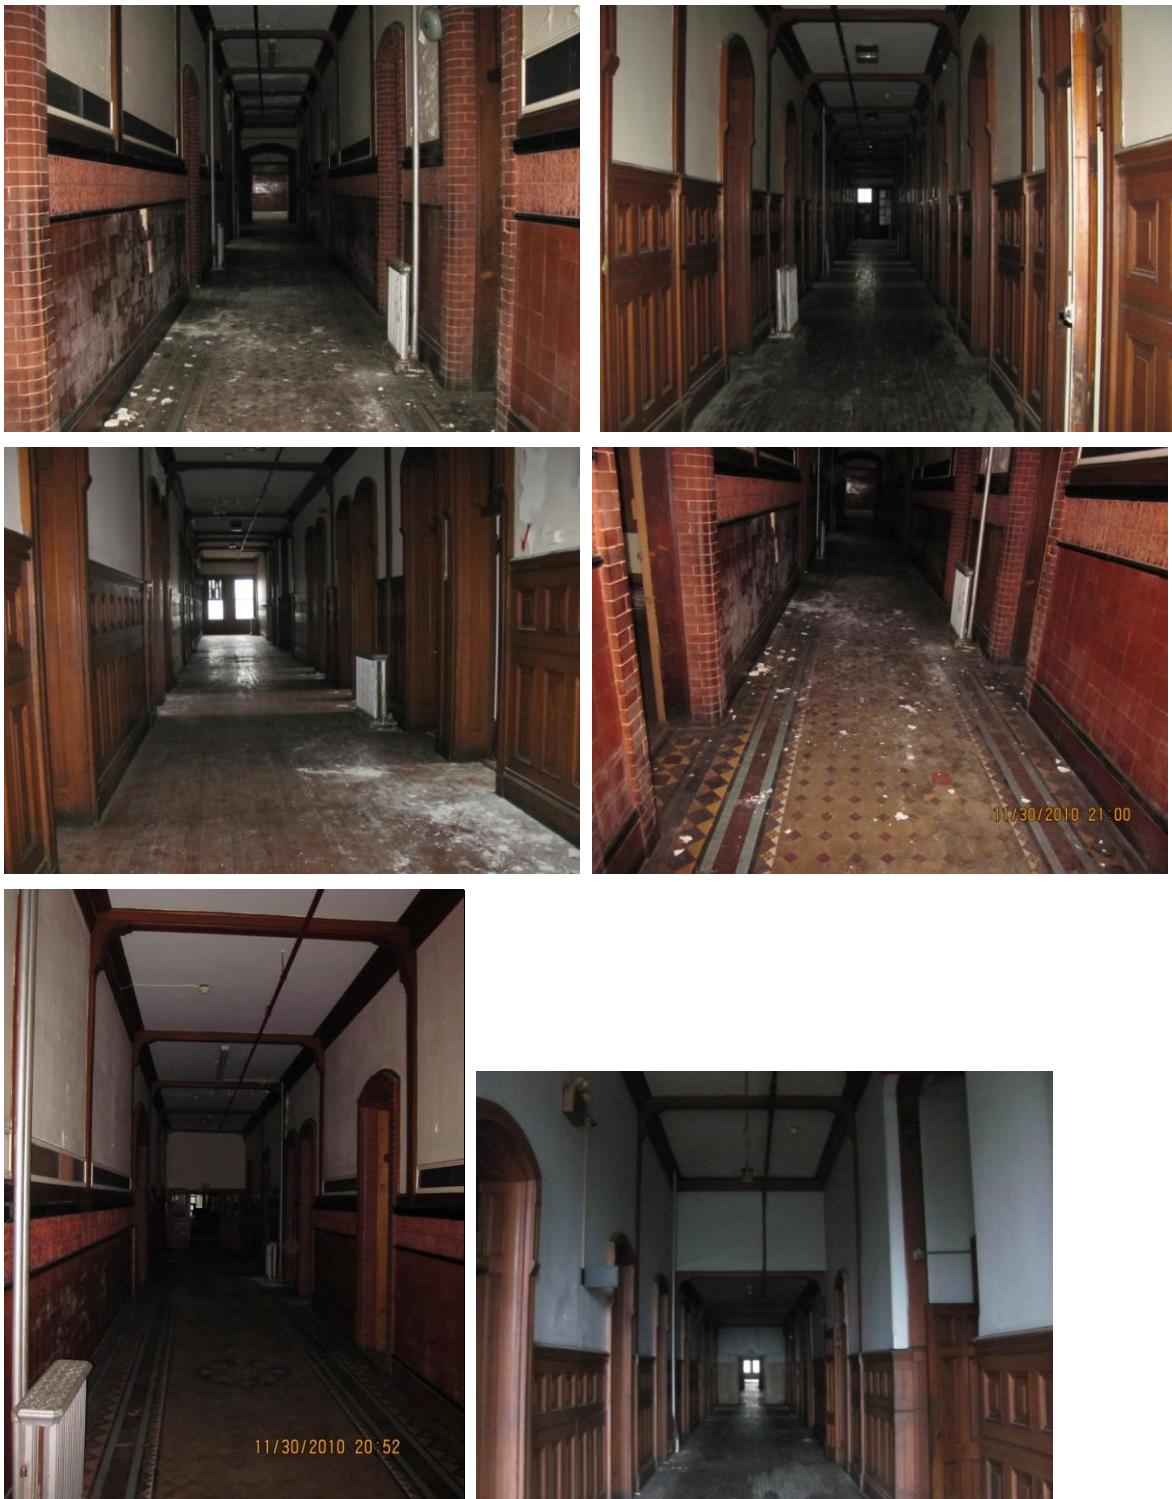
Typical Corridors. Corridor walls are structural and support the floor framing.

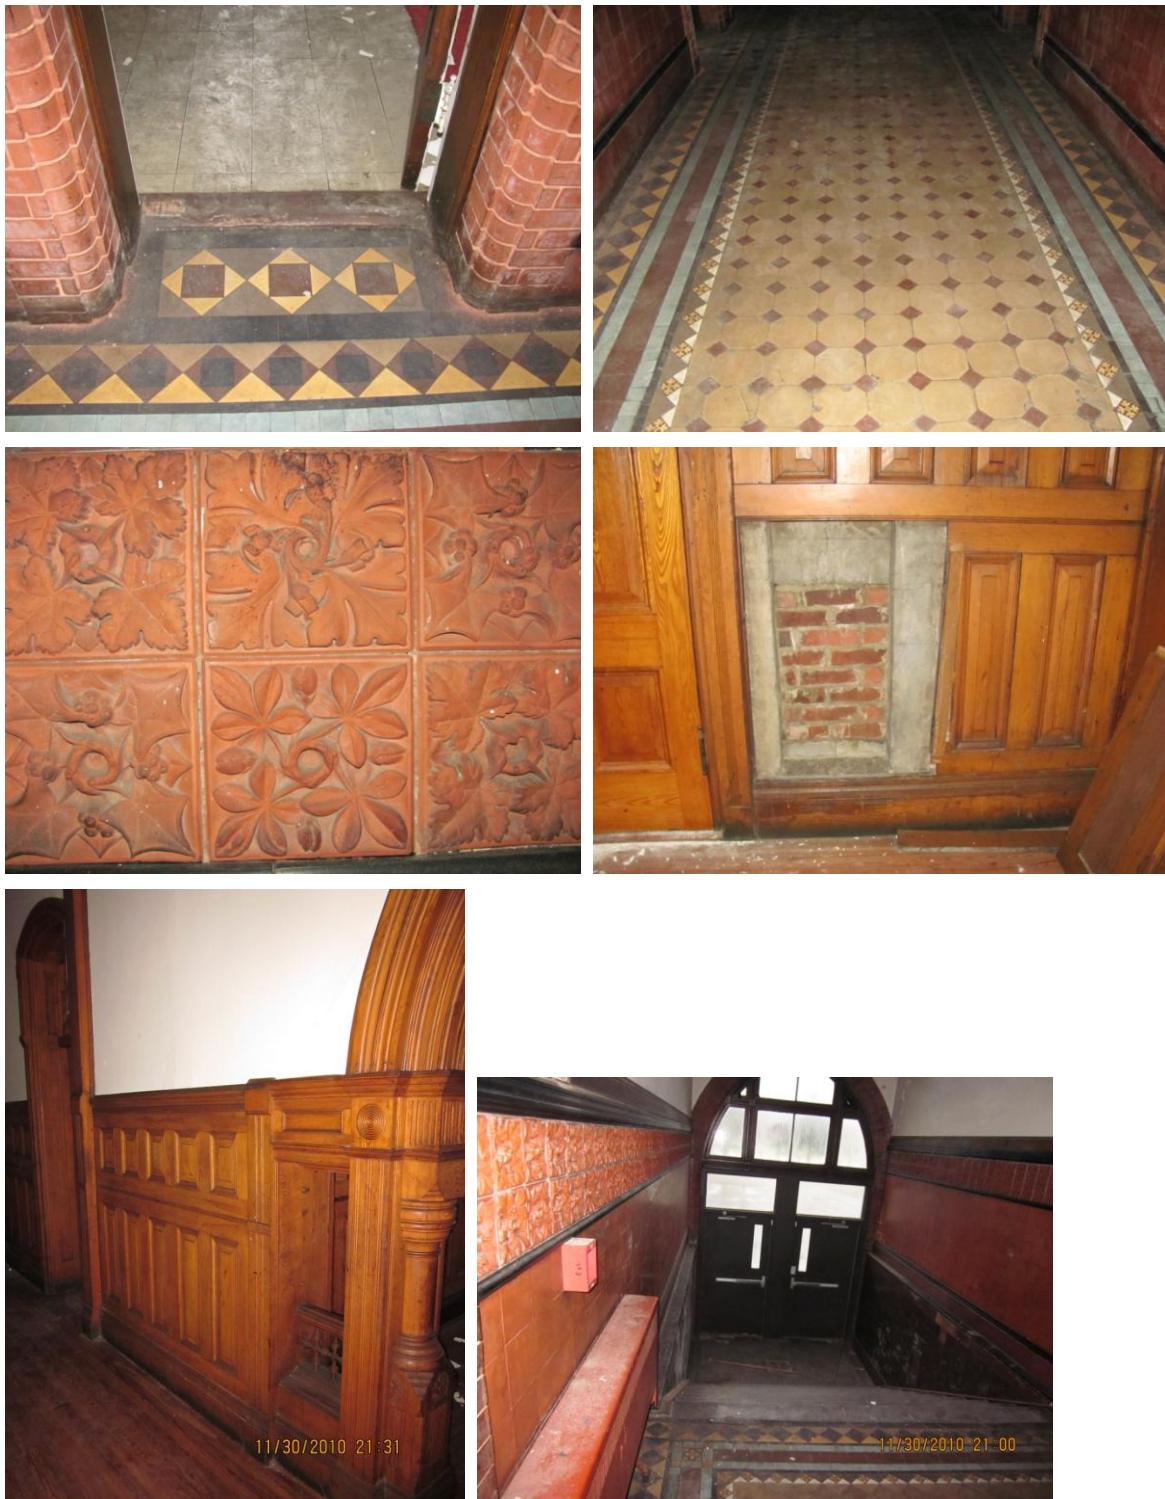
Corridor finish details

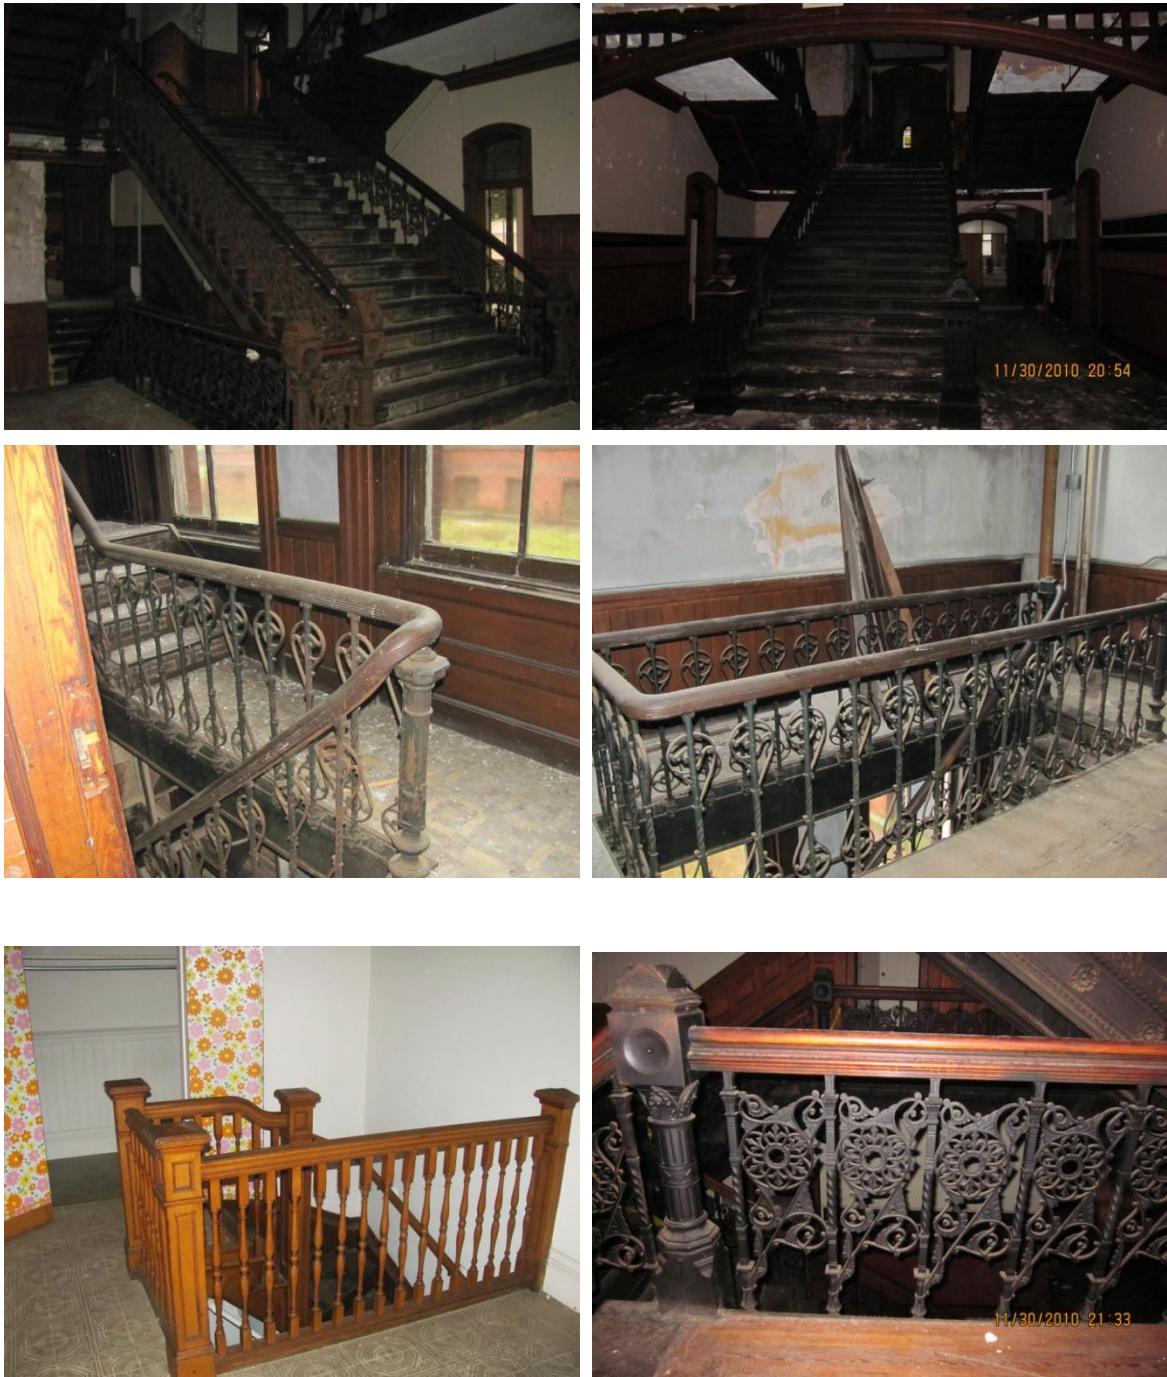
Typical stairs.

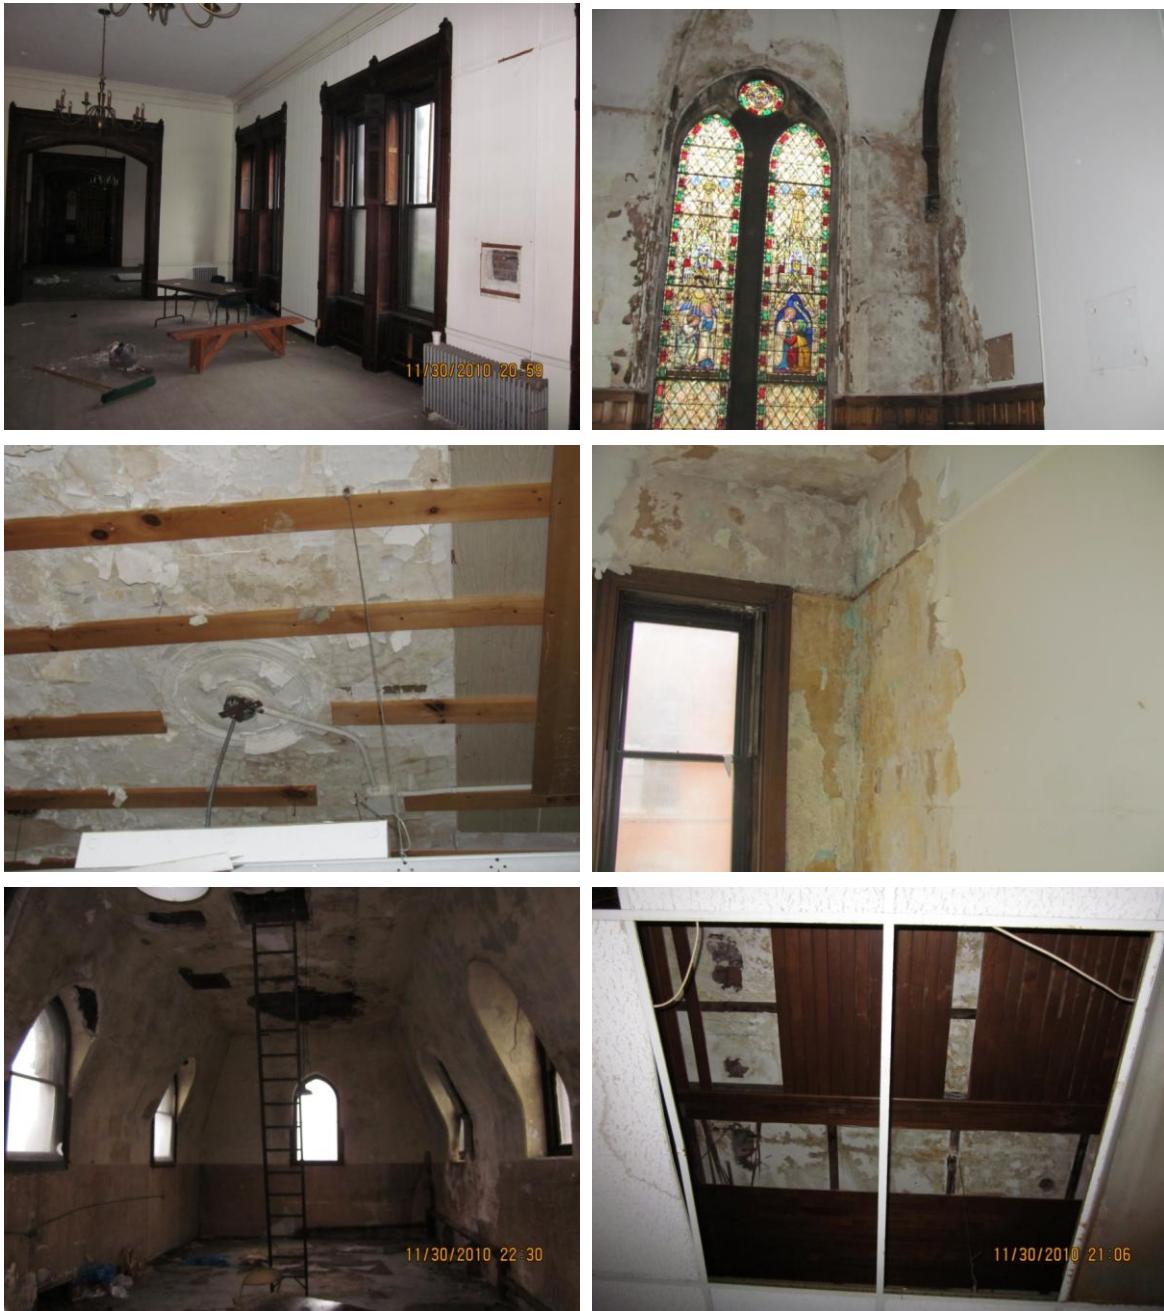
Typical rooms and finishes. Note that the water damage extends to virtually all rooms.

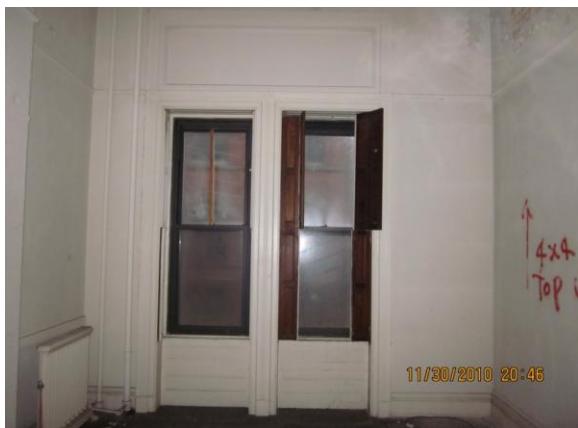
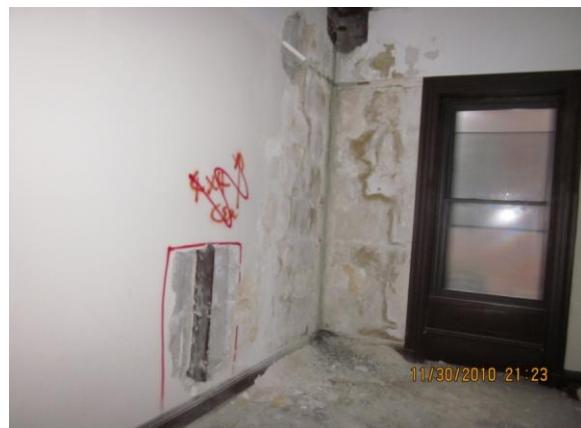
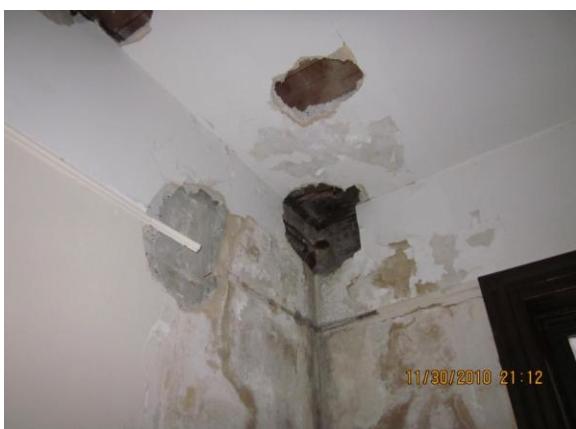
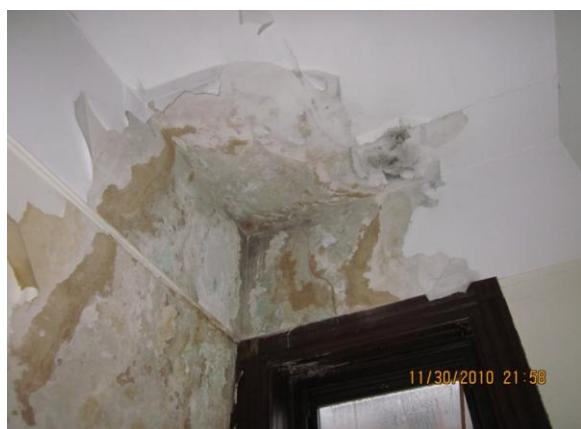
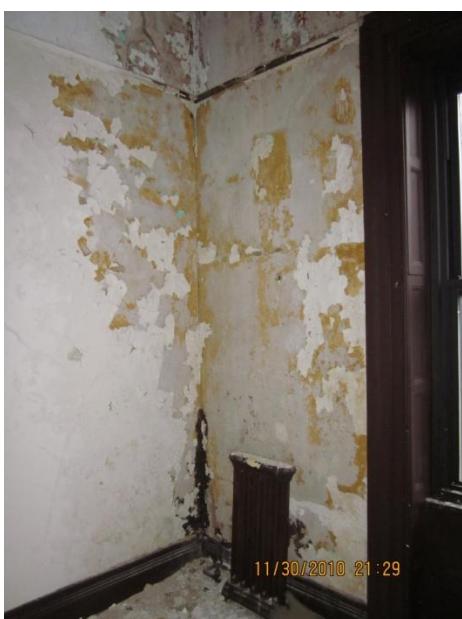
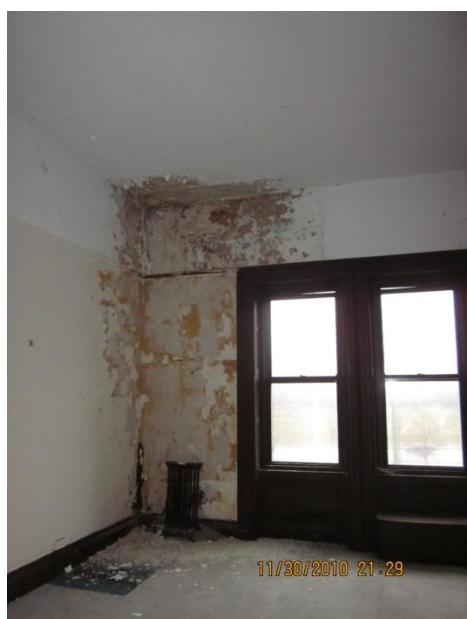
Typical room size and condition of finishes is evident in these photographs.

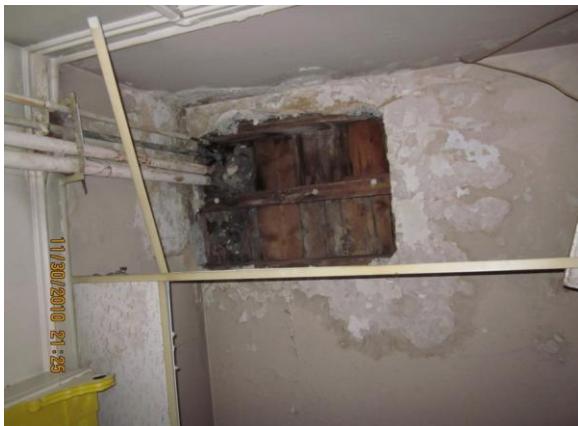
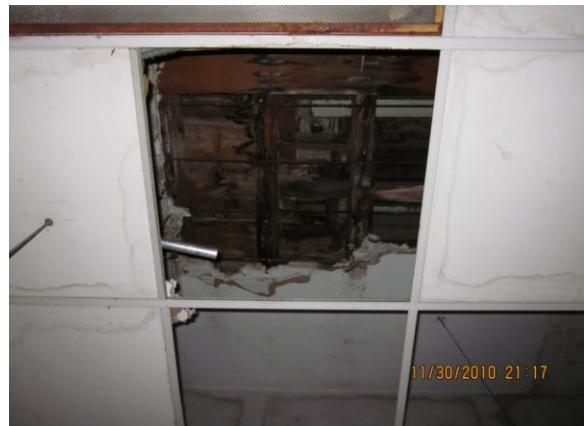
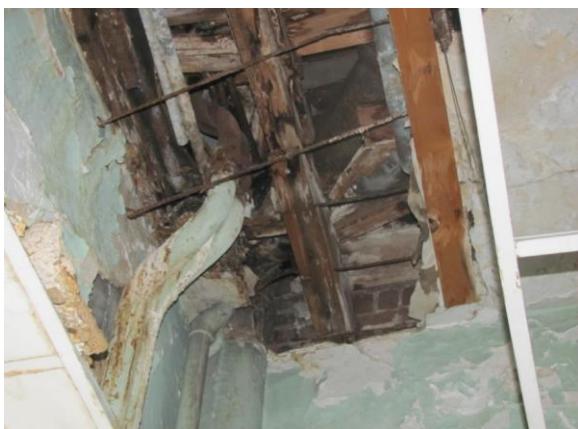
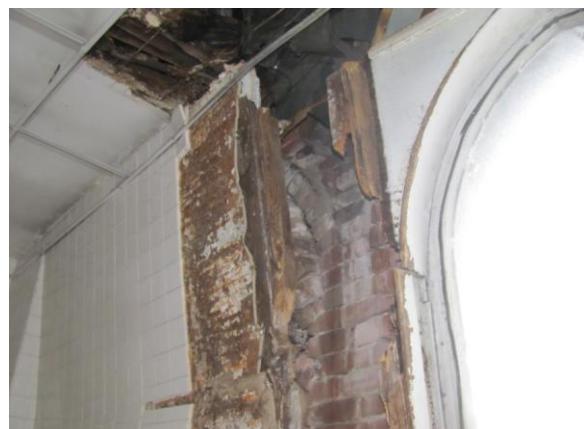
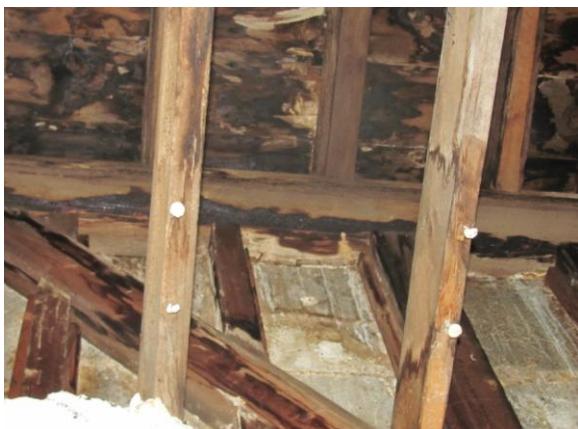
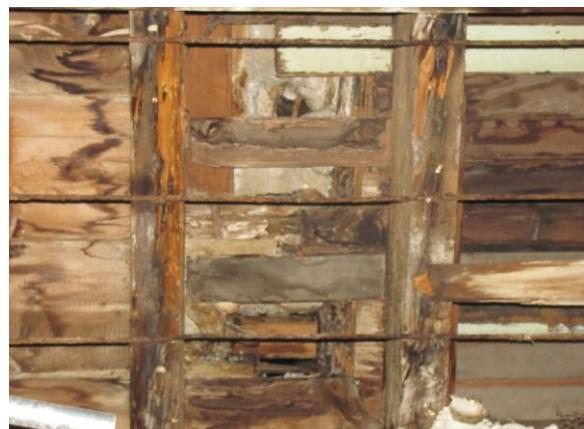
Damage to the wood floor and roof framing is extensive and serious.

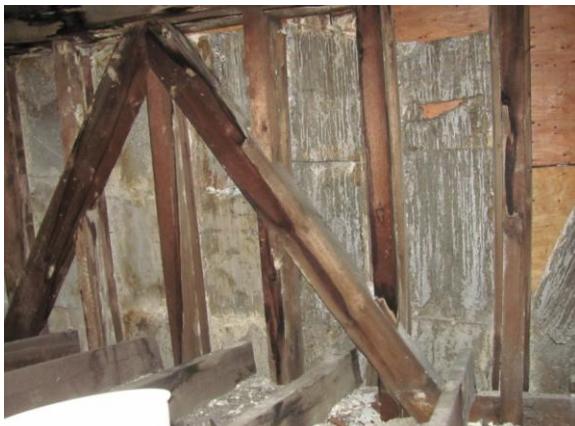
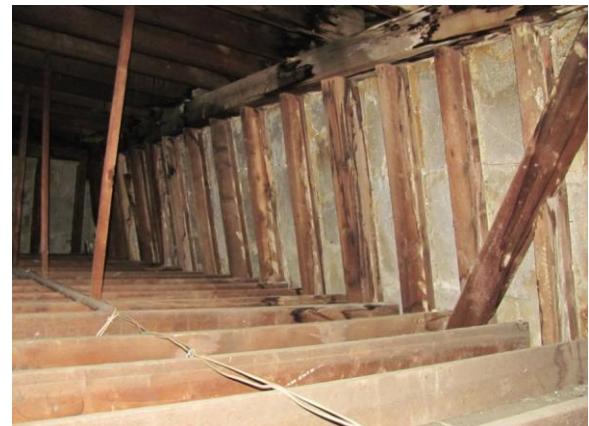
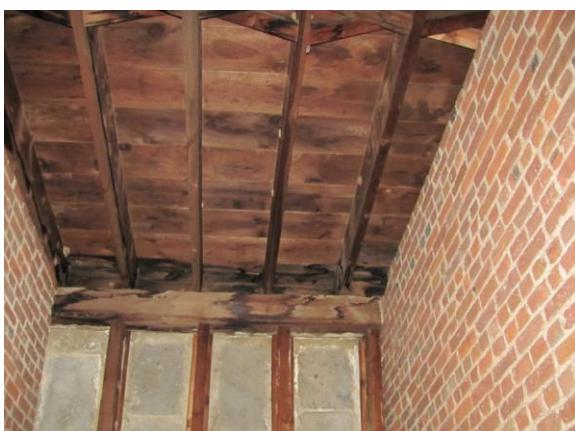
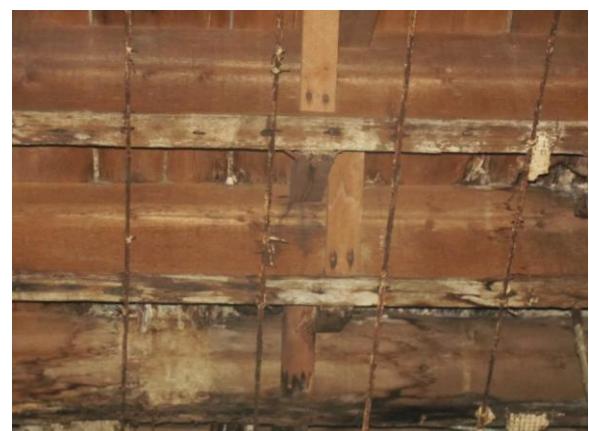
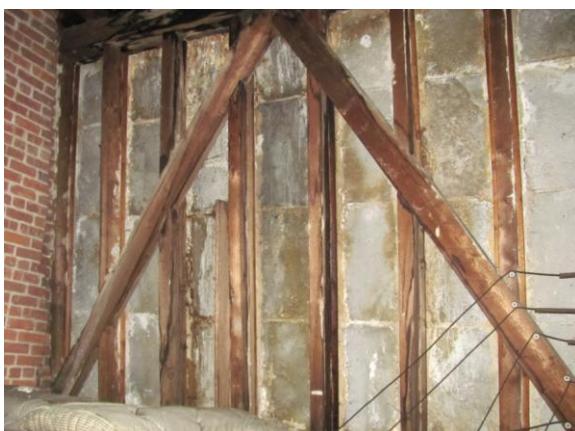
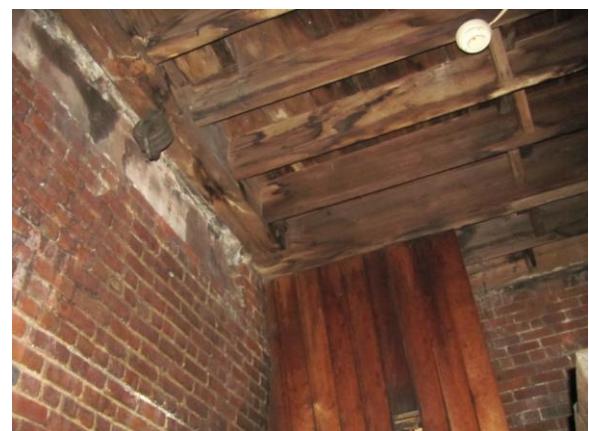
Virtually all of the roof members are deteriorated to some degree and will require extensive restoration or replacement.

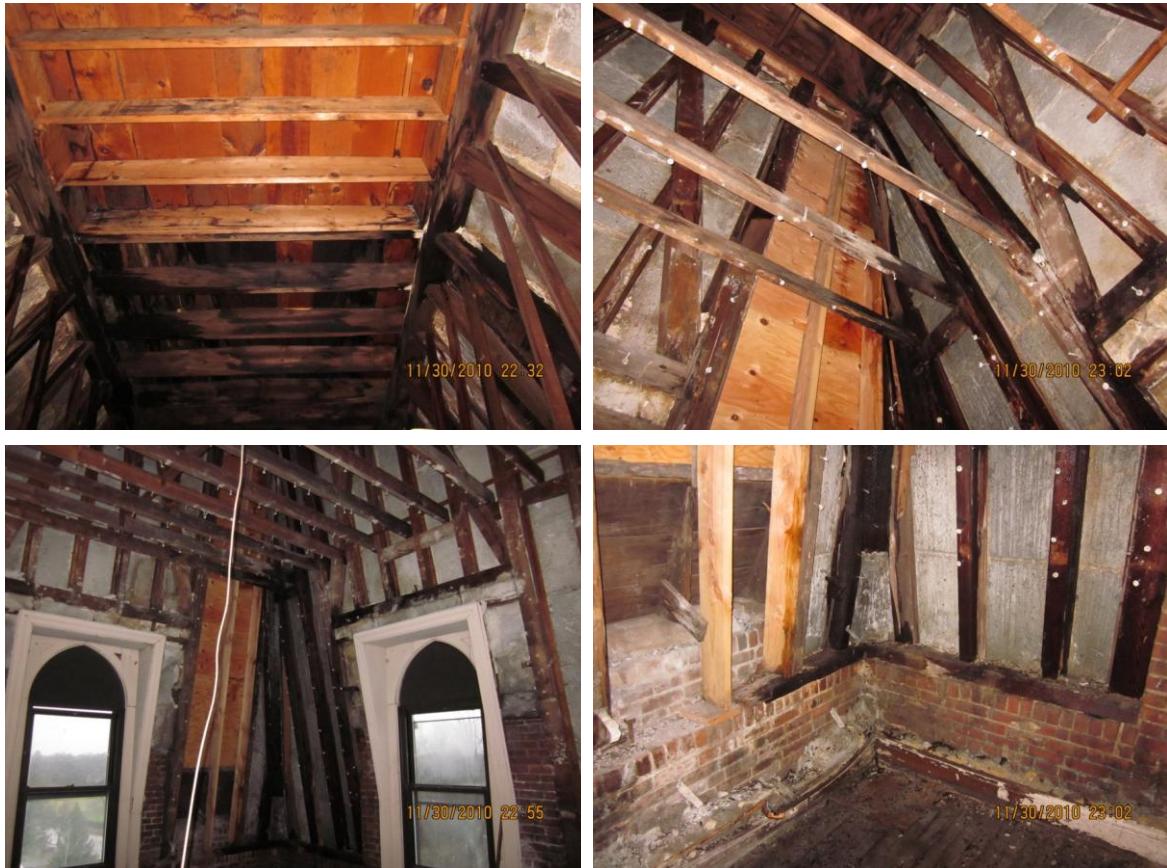
Areas of the roof have been replaced after structural failure. All of the rafters will need to be inspected and repaired.

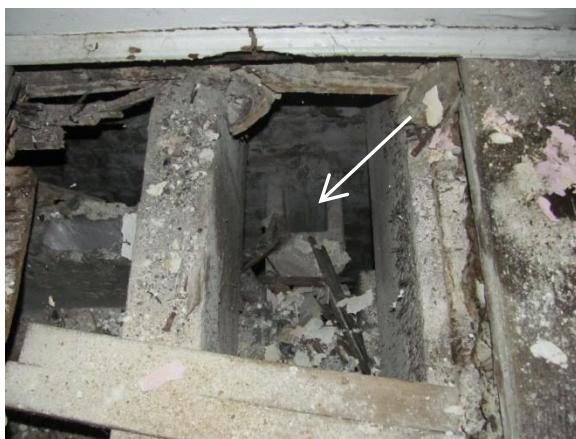
There is no fire-safing around the perimeter of the building. Cavities in the walls and floors extend from the roof to the basement, creating pathways for potential fire and smoke spread

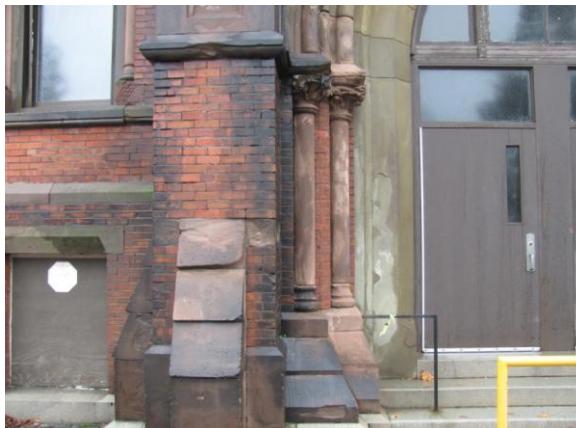
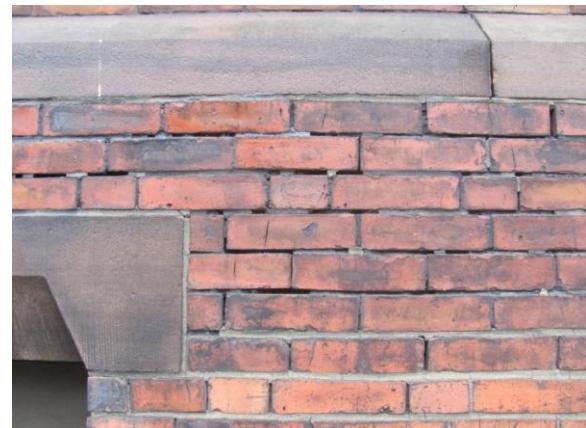
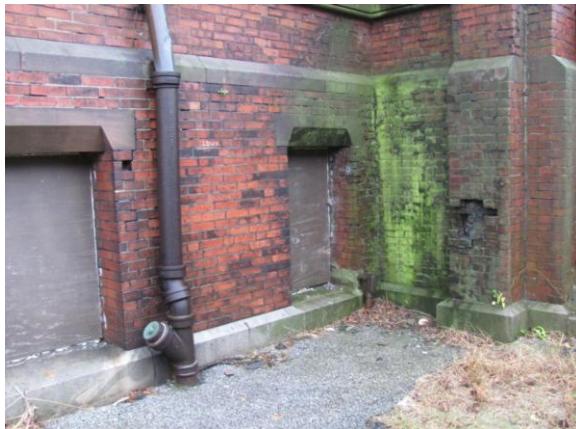
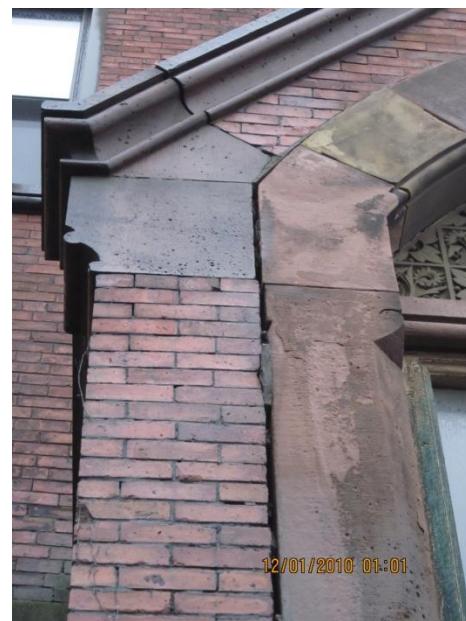
Areas of the brick have been badly damaged by water. In some areas, most of the mortar joints have been washed away and the stone trim is loose.

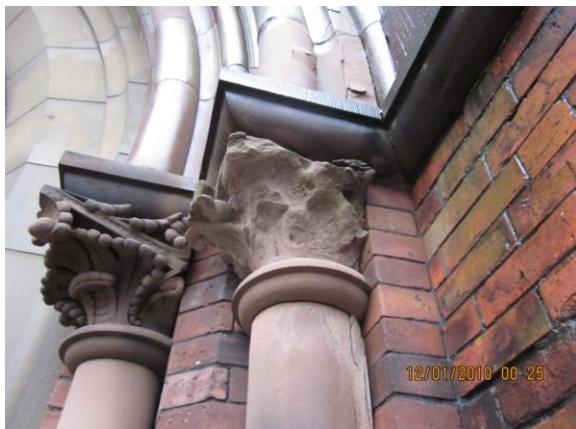
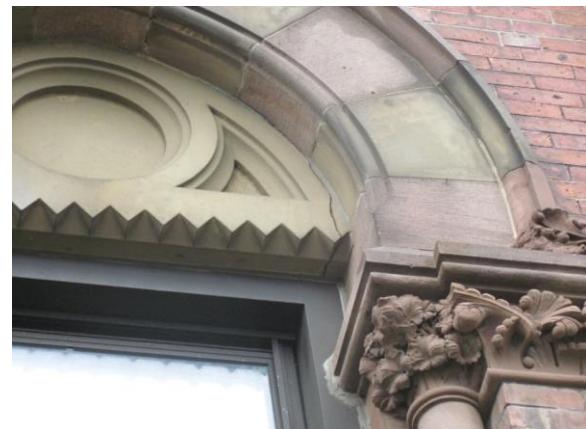
In areas the stone trim is cracking and delaminating

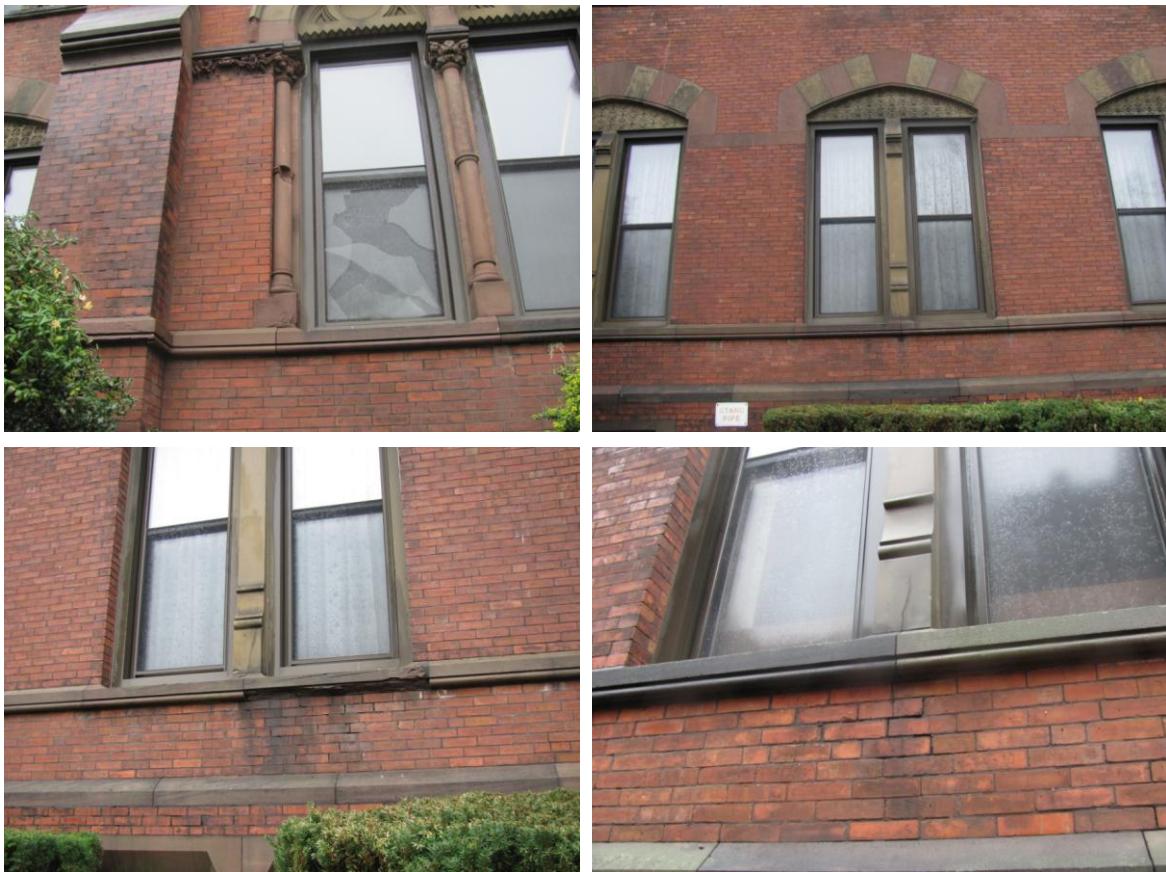
Cracks are developing at most of the stone piers between windows on the ground floor and the stone is deteriorating.

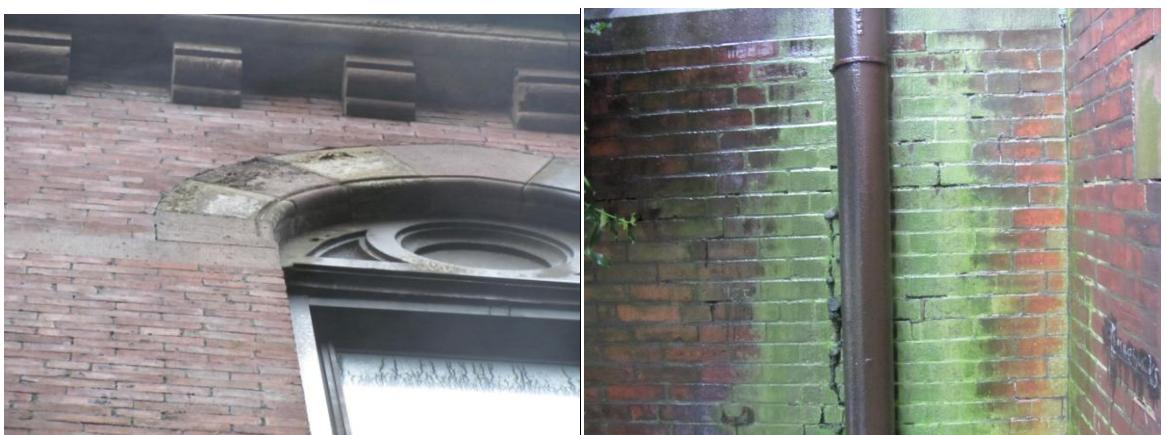
Some of the stone is delaminating, and some of the brick is severely damaged by water.

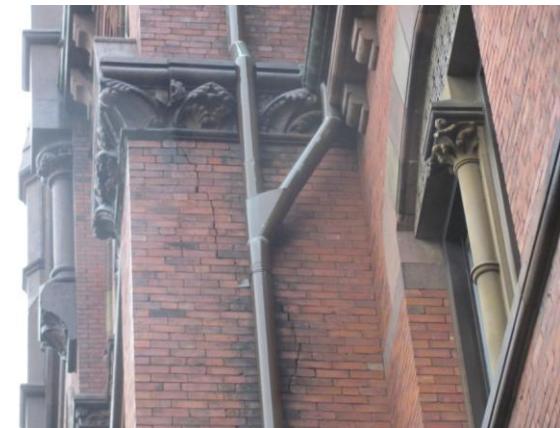
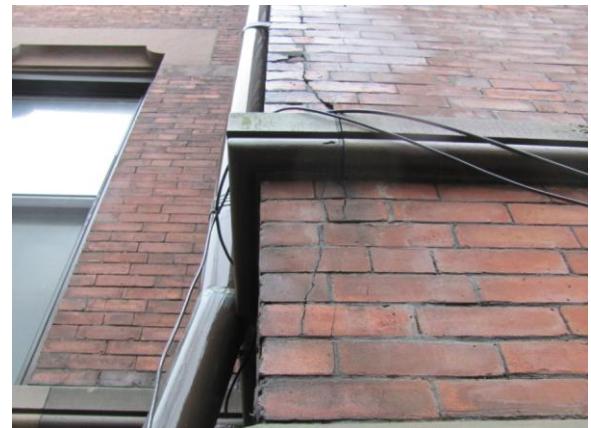
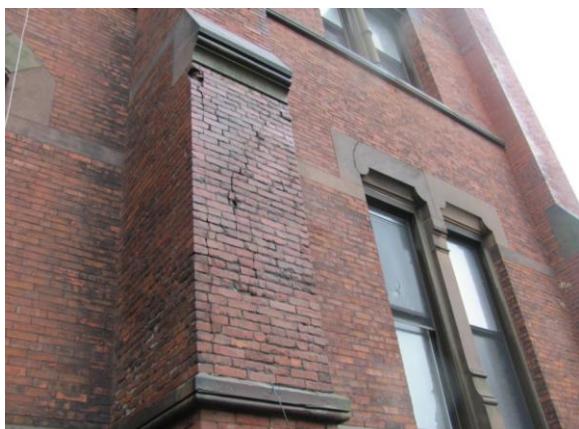
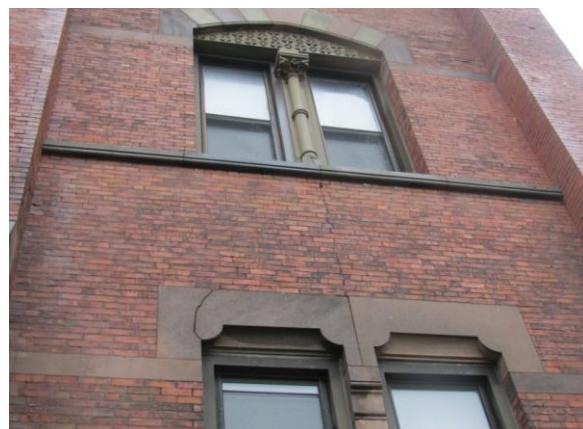
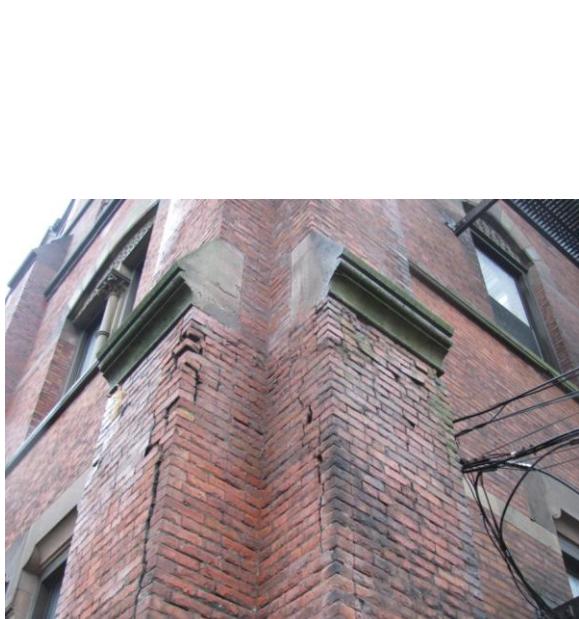
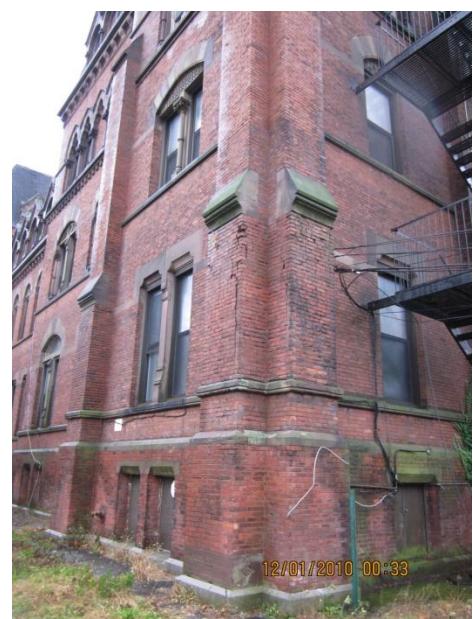
Structural cracks are developing at piers and corners of the building throughout

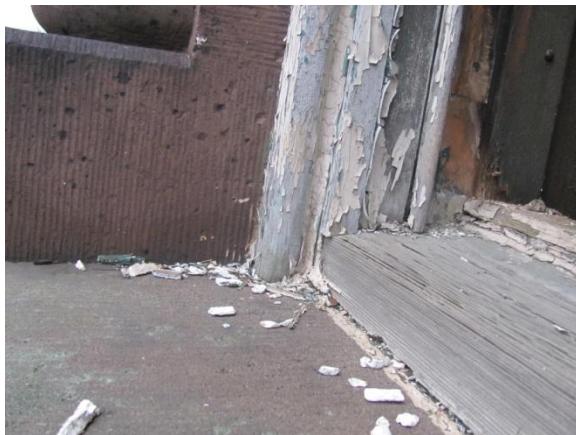
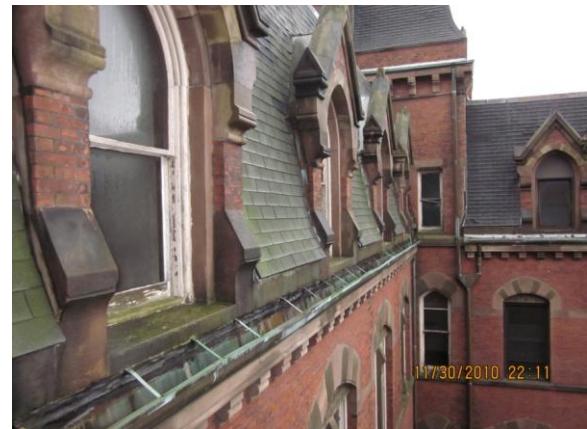
The wood windows are in poor condition. The gutters and downspouts are in need of extensive repair and replacement. The shingle roofs will need to be replaced with slate to restore the building to its original condition.

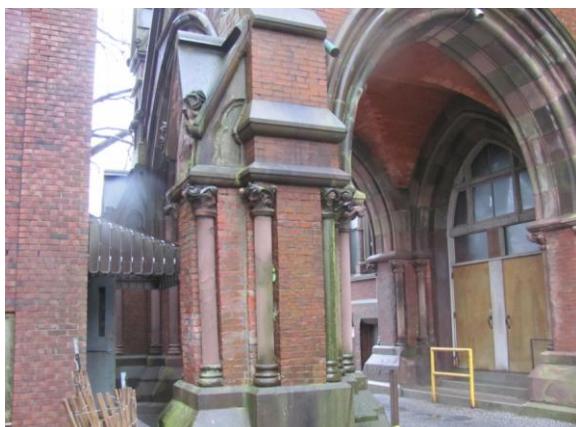
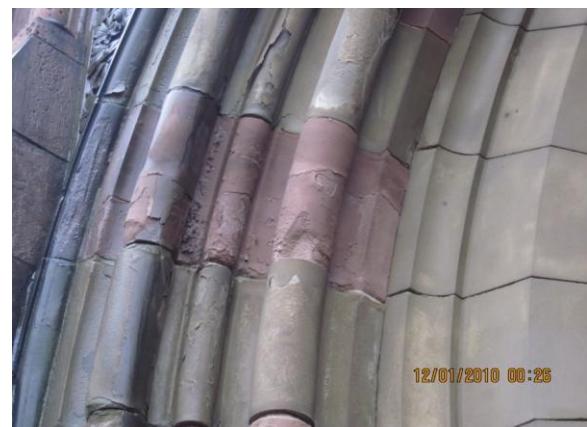
The porte-cochere is in poor condition but could be restored if the community wishes to salvage it as a stand-alone monument.

This option envisions demolishing the entire building except for the porte-cochere, which would be restored as a stand-alone monument. This would require protecting the porte-cochere during demolition, controlled demolition around its perimeter, and stabilization and restoration of the structure. This type of restoration requires very specialized crafts trades, and we estimate that the premium above total demolition would be approximately \$500,000, not including site improvements around the monument. There would also need to be a continuing commitment to maintain the monument over time.
