Comparative Analysis Executive summary

Saint Paul's Complex
Garden City, NY, 11530

EXECUTIVE SUMMARY

Existing MEP/FP Condition Evaluation & Adaptive Reuse Analysis

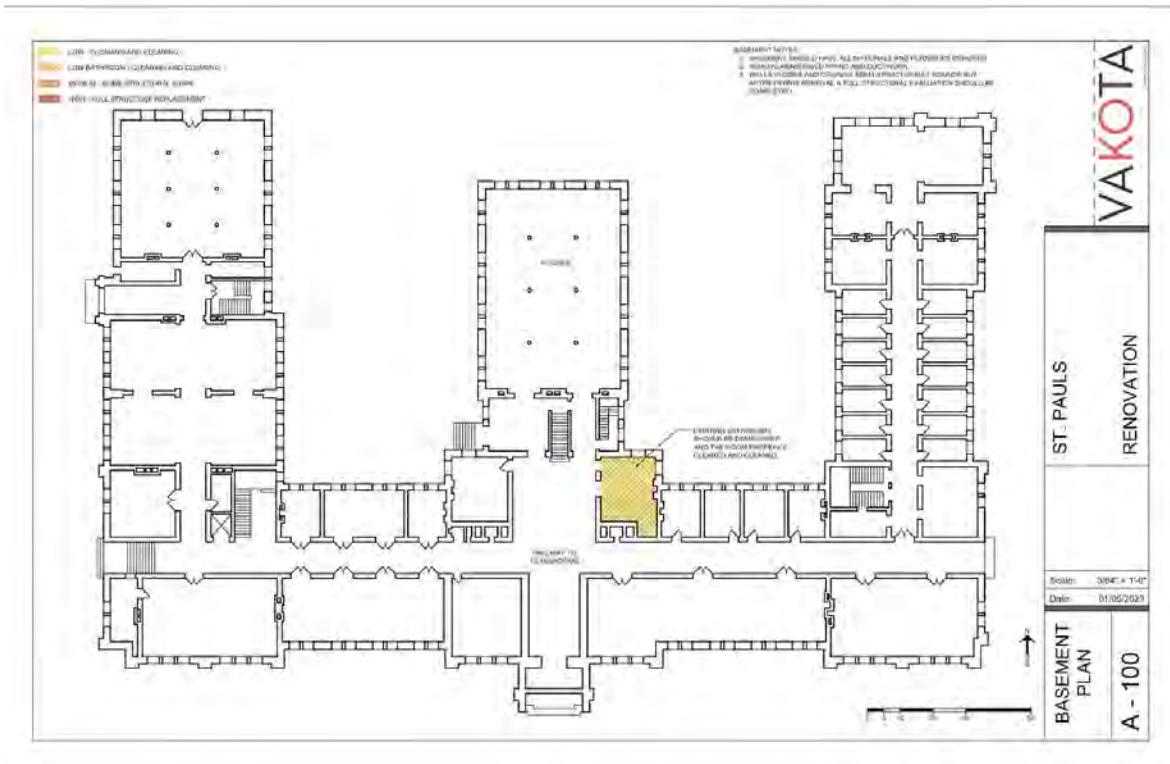
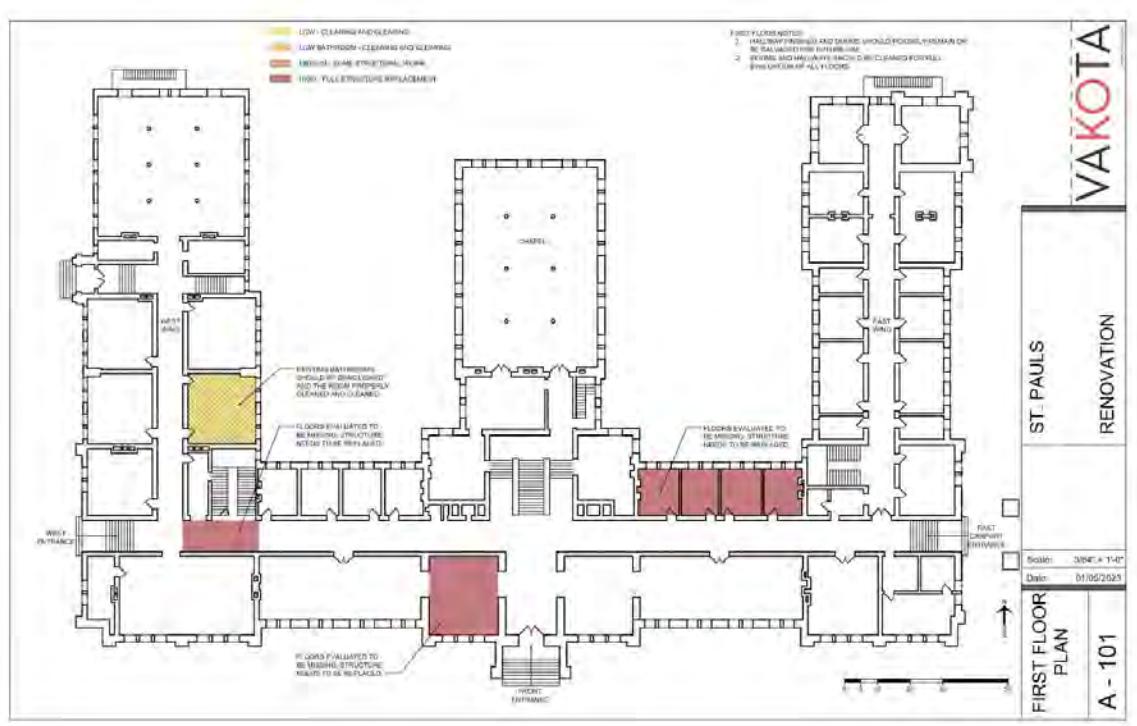
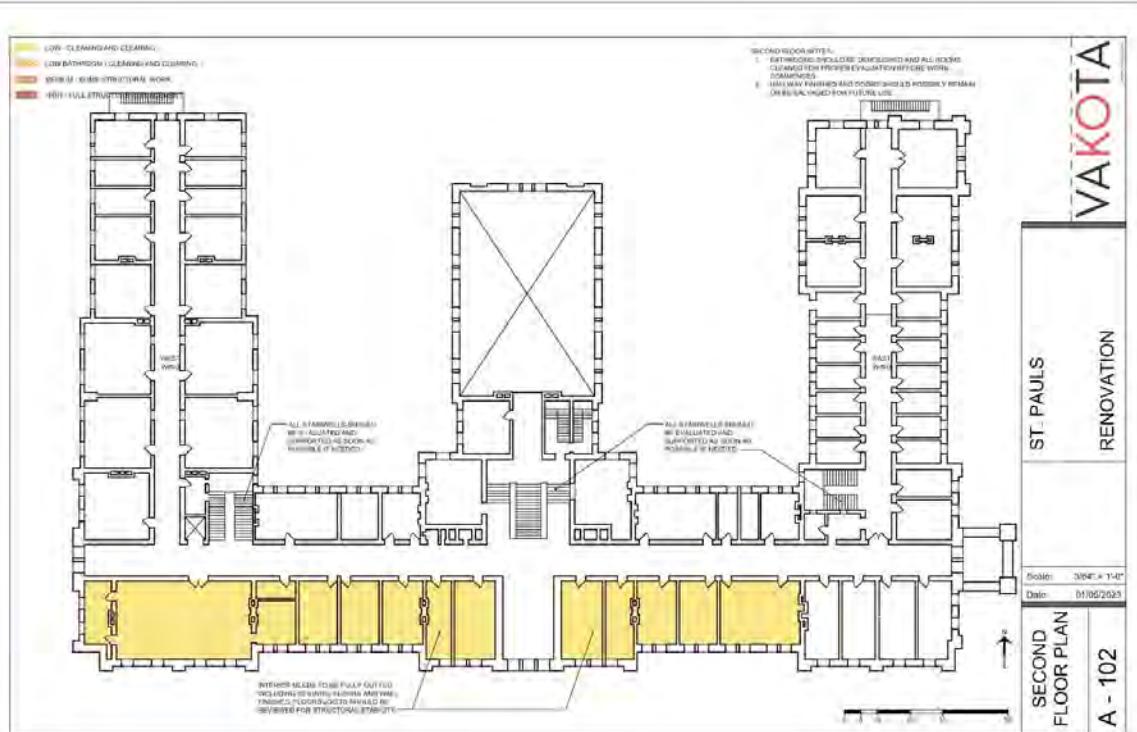
The following diagrams show the existing conditions as observed on December 09, 2022. No extensive probes or reviews were performed. Areas with noticeable deterioration, environmental hazards, and structural compromise have been highlighted. An extensive structural review was not performed although random samples of walls, ceilings, and floors were taken for asbestos and moisture testing.

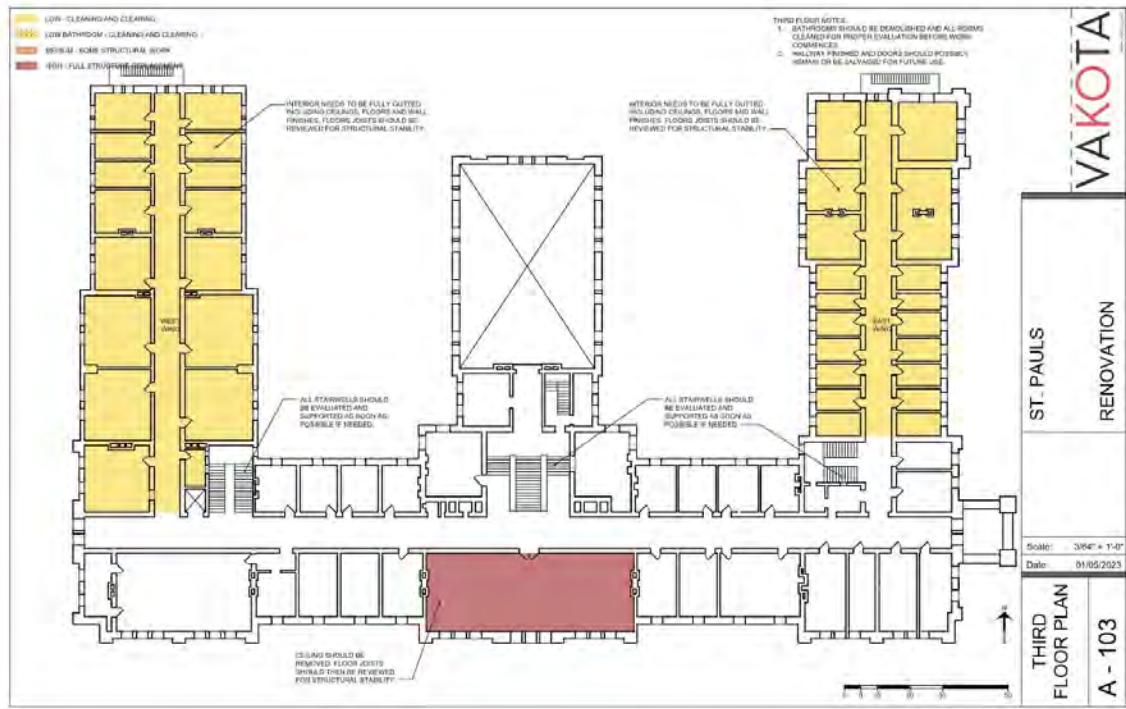
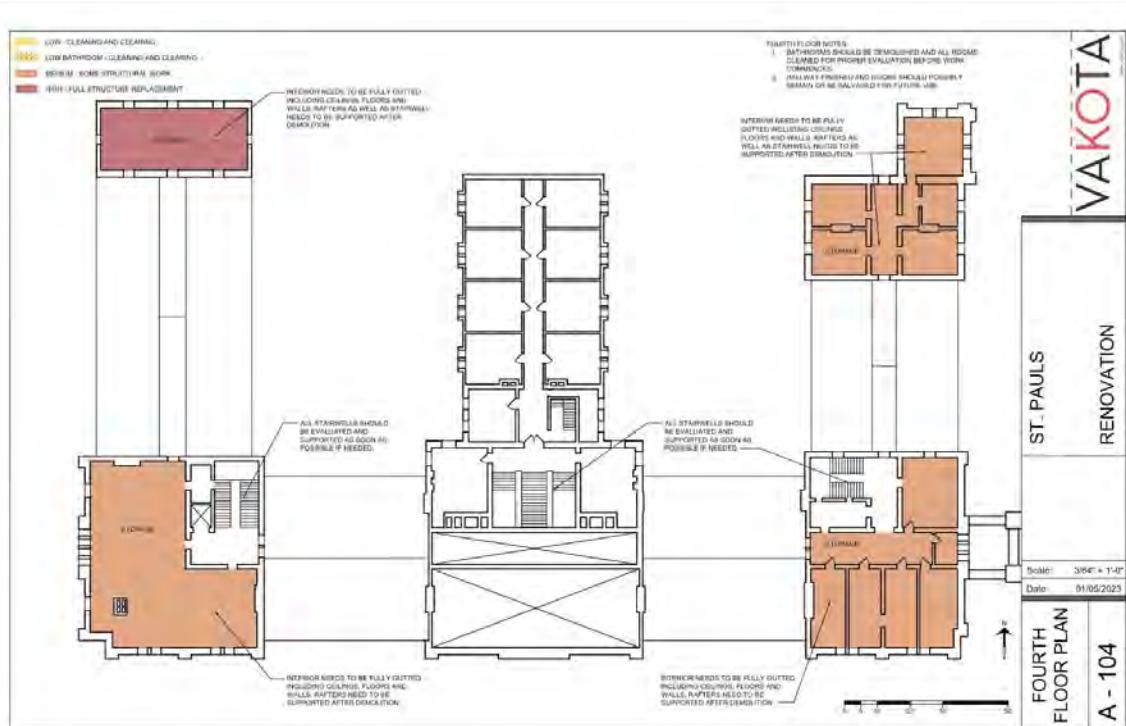
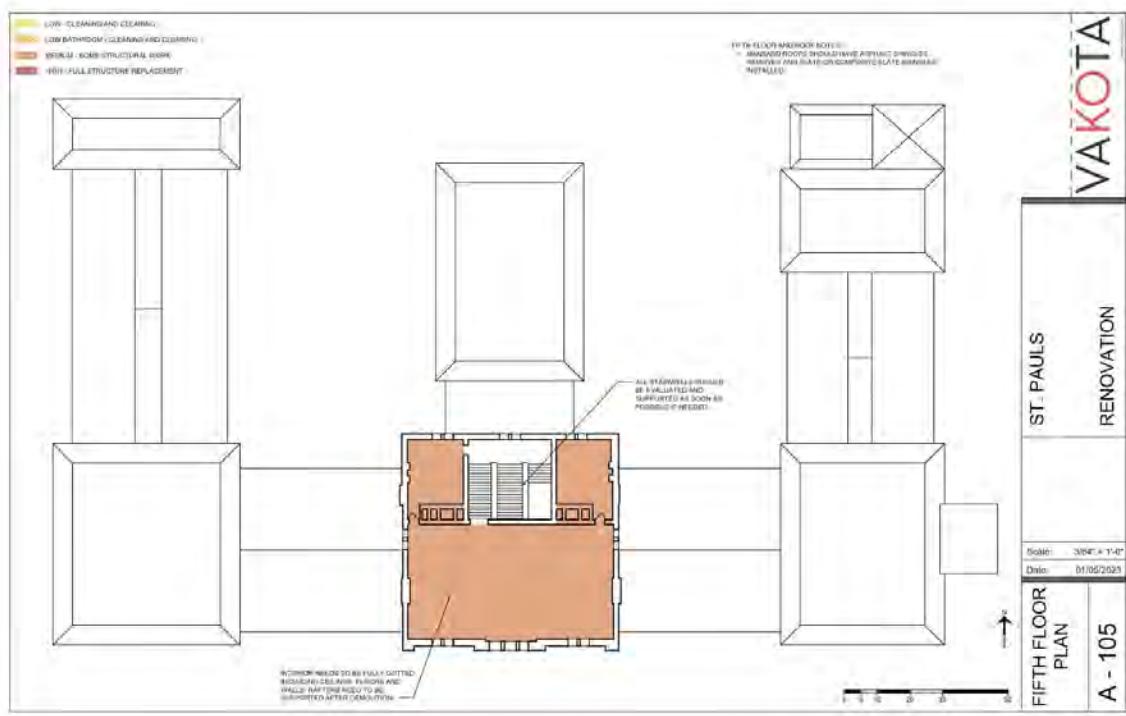
LOW - CLEANING AND CLEARING

LOW BATHROOM - CLEANING AND CLEARING

MEDIUM - SOME STRUCTURAL WORK

HIGH - FULL STRUCTURE REPLACEMENT
